KERNODLE LAKE DAM NO. 1

JACKSON COUNTY, MISSOURI

**PHASE 1 INSPECTION REPORT
NATIONAL DAM SAFETY INSPECTION**

PHASE I REPORT
NATIONAL DAM SAFETY PROGRAM

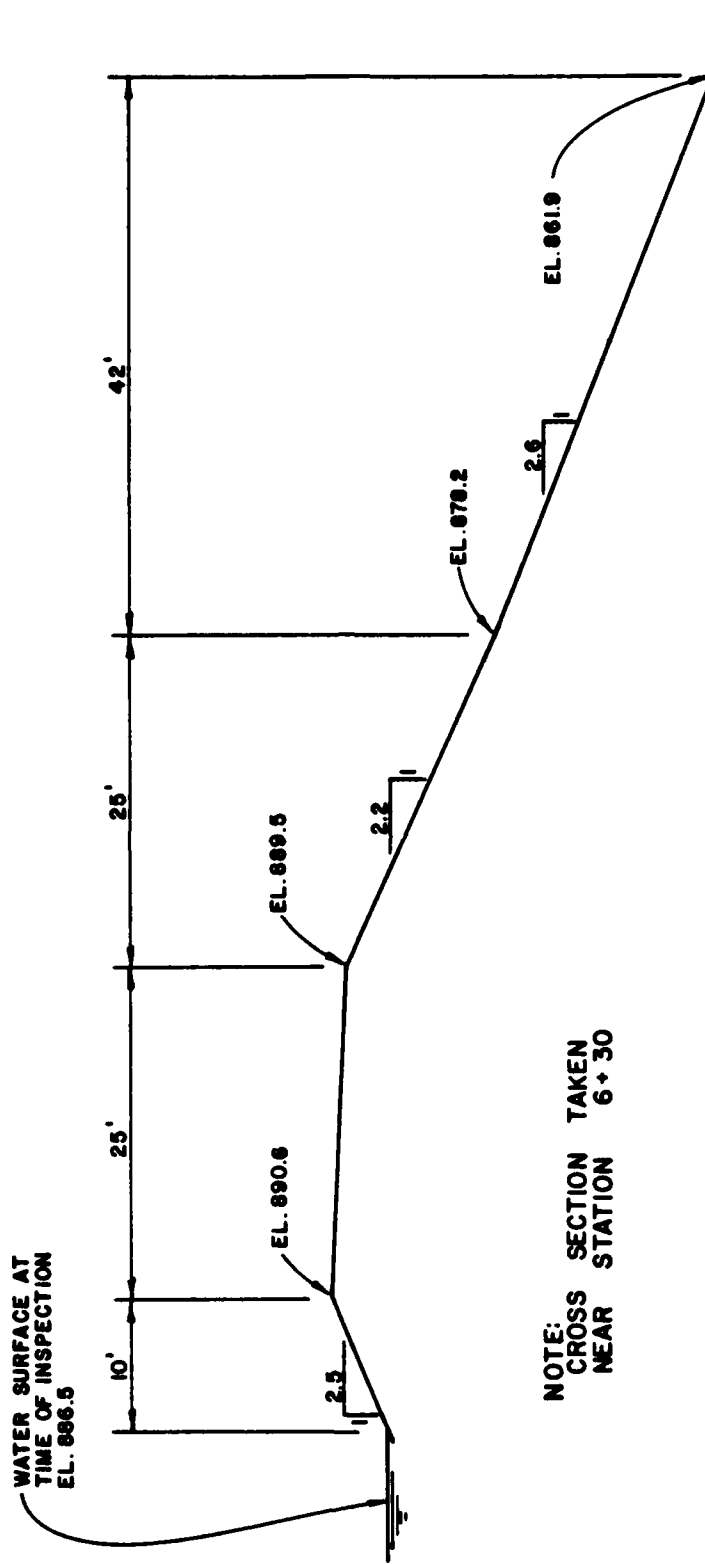
KERNODLE LAKE NO. 1 EMBANKMENT CROSS SECTION

NOTE: CROSS SECTION TAKEN
NEAR STATION 6+30

SECTION DATA OBTAINED
FROM FIELD SURVEY.
